# Rehabilitation of the Otis Reservoir Dam: Improving Cost Effectiveness by Including Bridge Placement

*Combining efforts to address dam safety issues with access and transportation issues provided a win-win situation for all of the involved parties.*

MATTHEW A. TAYLOR & JOHN G. DELANO

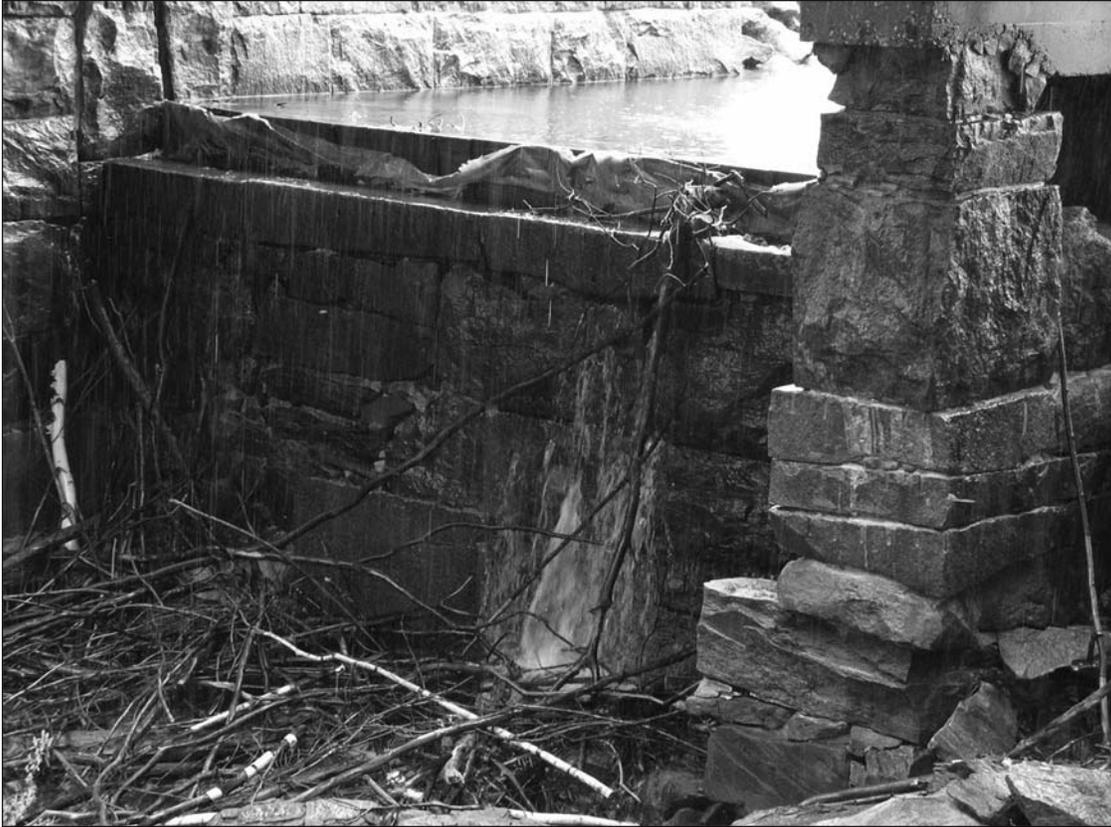
**FIGURE 2.** View of the deteriorated and leaking conditions at the spillway prior to rehabilitation.

- The deteriorated masonry and leakage conditions at the spillway (see Figure 2) and the downstream masonry wall; and,
- The erodibility of the “emergency spillway” over the main embankment section of the dam.

To address most of the main dam safety concerns, a reconstructed spillway with a hydraulically actuated crest gate was chosen as the preferred alternative. The crest gate option provided additional hydraulic capacity while also improving the DCR’s ability to manage the reservoir level, most importantly, during the annual winter drawdown.

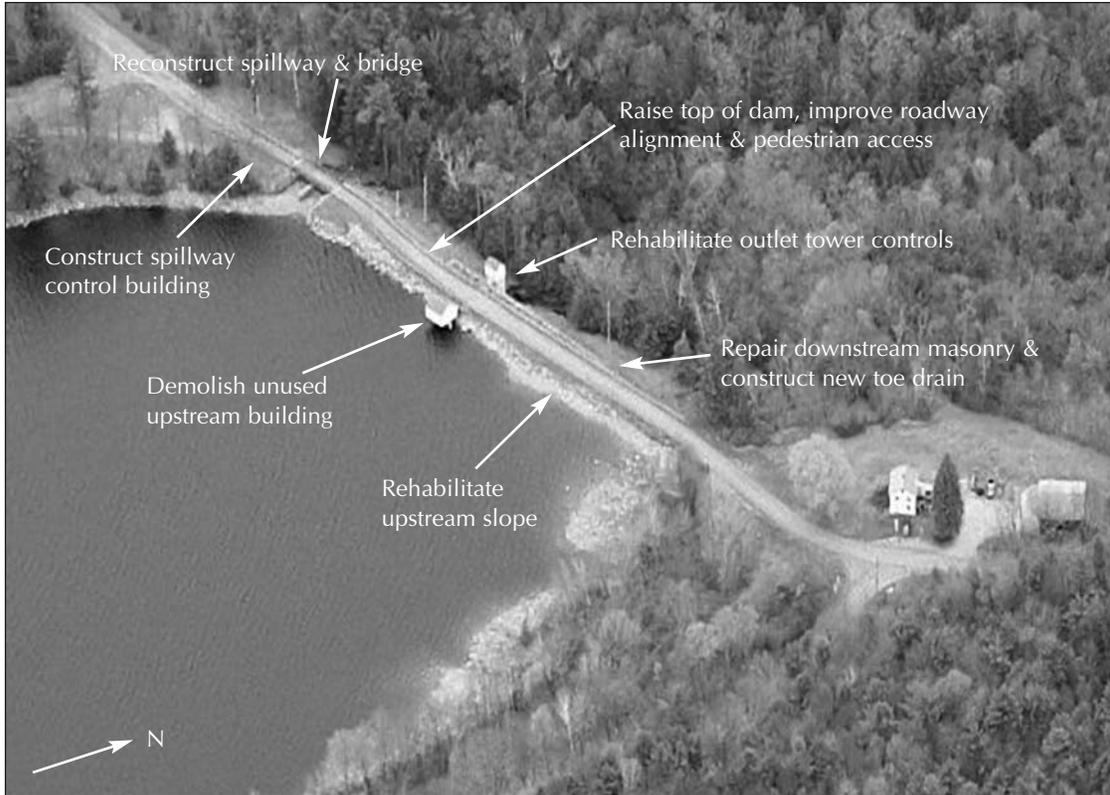
**FIGURE 3. The locations of repairs/improvements on the dam.**

Other improvements included in the dam rehabilitation, as shown in Figure 3, were:

- adding a new gatehouse on the left abutment of the dam;

- raising the top of the dam by adding up to 3 feet of embankment fill;
- repointing the downstream masonry wall;
- extending the downstream toe drain;
- adding a reinforced concrete splash pad at the base of the downstream masonry wall;
- restoring the rip-rap slope protection on the upstream and portions of the downstream slopes; and.
- installing new slide gates on the inside upstream face of the downstream outlet tower.

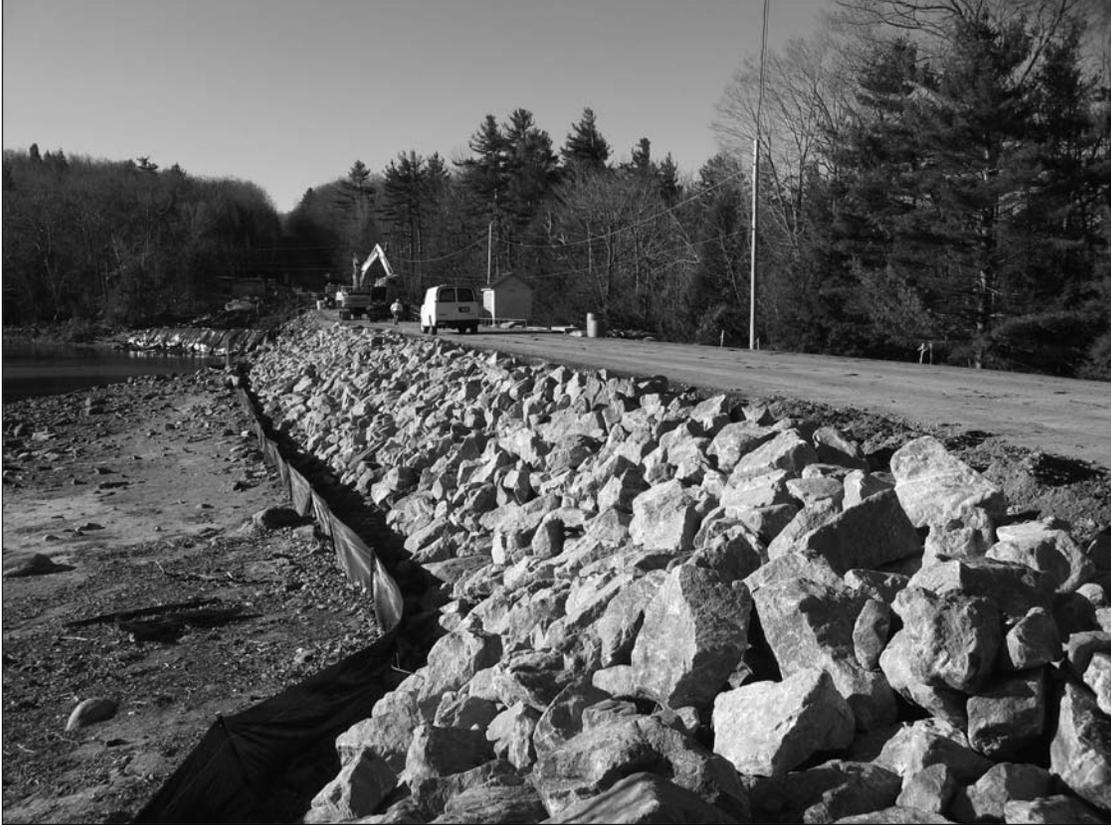
**FIGURE 5. Improvements to the dam crest and upstream slope.**

- the construction of the toe drain and splash pad;
- raising of the embankment crest by 3 feet;
- placement of new upstream and downstream riprap slope protection (see Figure 5 on page XX);
- demolition of the masonry spillway;
- construction of the new reinforced concrete spillway/bridge abutments;
- installation of the new stop logs;
- installation of the new bridge;
- demolition of the upstream gatehouse; and,
- construction of the new crest gate gatehouse at the left abutment.

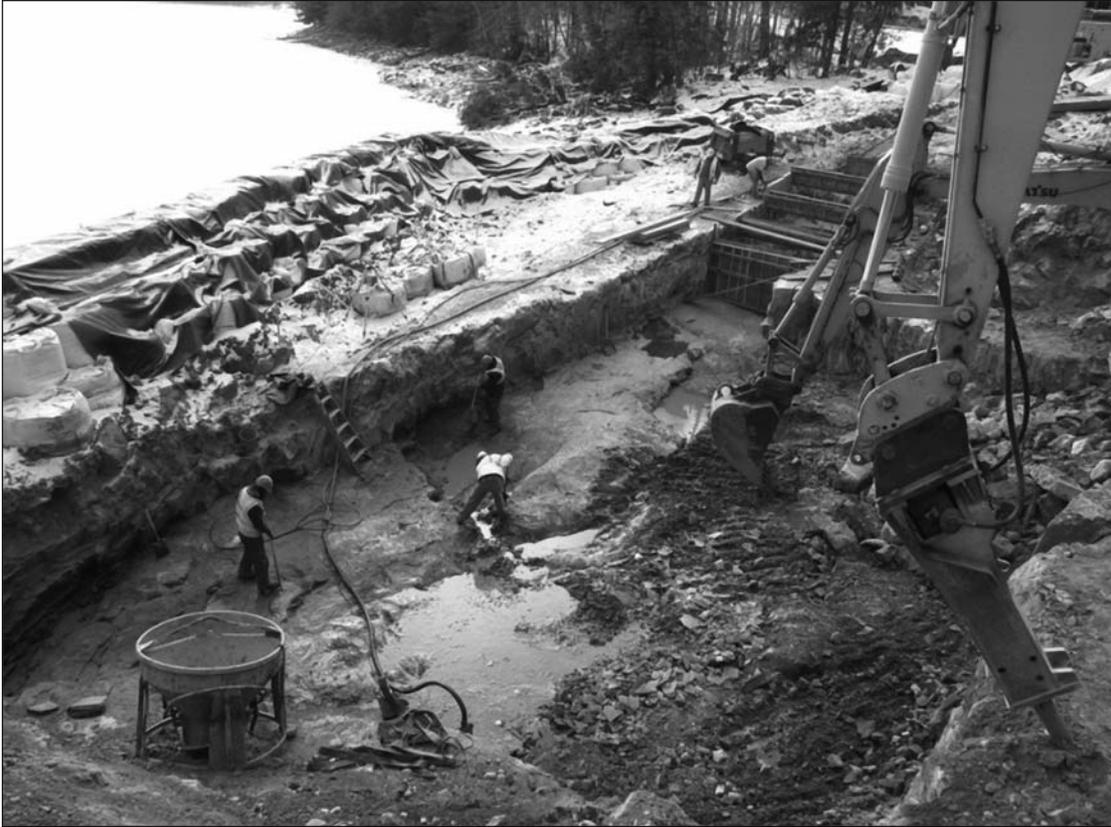
**FIGURE 6. Bedrock excavation at the spillway.**

Because the invert of the new crest gates was almost 8 feet lower than the original spillway crest, bedrock excavation and removal within the spillway footprint was required for foundation construction. The excavation required for the new spillway foundations

was approximately 100 by 80 feet in area, and required cuts into the bedrock of up to about 7 feet.

The bedrock conditions in the area of the spillway were generally less competent than it was anticipated during design. Because the top of competent bedrock was generally about 1 to 4 feet deeper than the design bottom of footing grades, approximately 150 additional cubic yards of concrete were required to reach the design footing subgrade elevations. The final bedrock surface was cleaned out with compressed air prior to the placement of the concrete. At the east bridge abutment, a “shear key” into the bedrock subgrade was added because of the lower than anticipated competent bedrock surface. This shear key was added to increase the passive resistance for the training wall/bridge abutment foundation.

Excavation of the gneissic bedrock was accomplished with a combination of ripping with an excavator and hoerammimg. Due to the fracture patterns in the bedrock, controlled blasting was not required. Figure 6 (on the previous page) shows an example of typical rock excavation at the spillway. Because the bedrock was fractured and rip-pable, the contractor utilized line drilling techniques on the outer perimeter of the excavation area to control the limit of the rock removal. Construction-induced vibrations were limited to the criteria set forth in 527 CMR 13.00, which provide vibration limits based on a relationship between peak particle velocity and frequency. Continuous and event-specific vibration monitoring was performed for the existing downstream masonry face of the dam, the downstream gate-

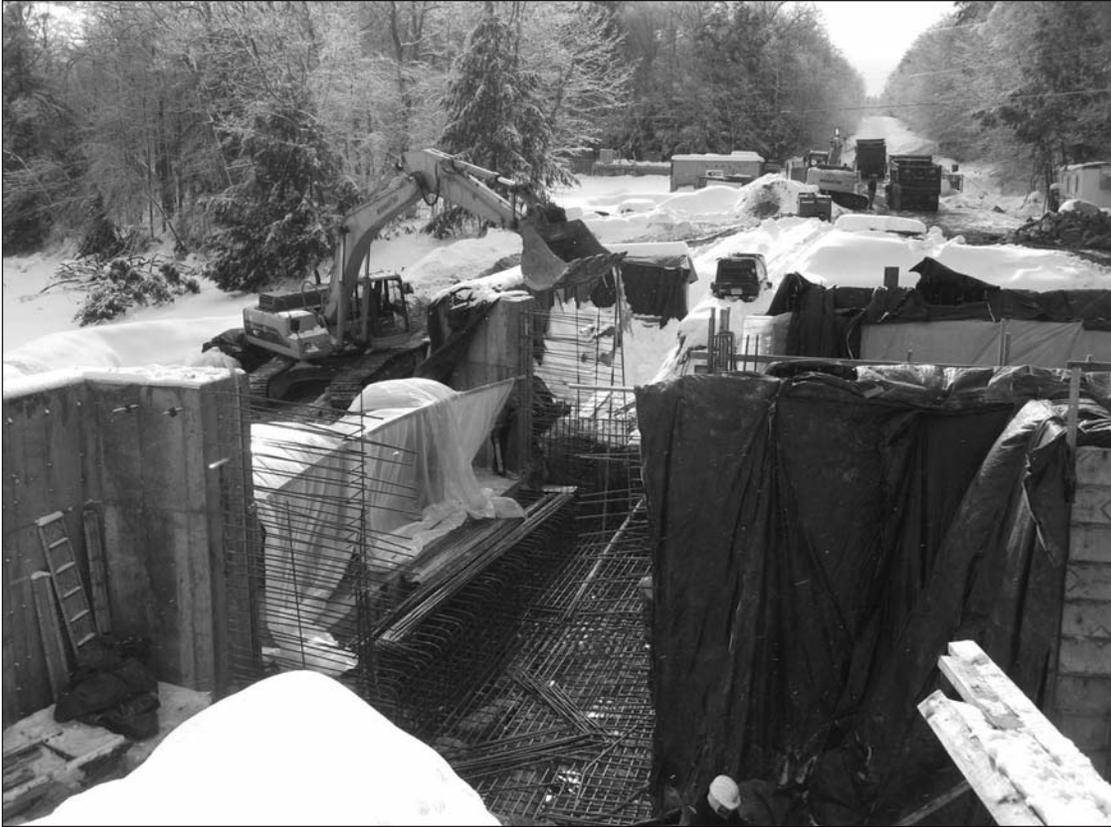
**FIGURE 7. Concrete work during winter 2010/2011 at the spillway.**

December 2010 marked the beginning of concrete placement for the new spillway. It also marked the beginning of one of the coldest winters in recent years in the Berkshires.

As shown on Figure 7, concrete was formed and poured in heated tents, and was typically allowed to cure for at least three days within the heated tents prior to stripping forms. Diligent maintenance of the heating system by the contractor allowed for concrete placement to occur relatively unimpeded despite the cold weather. Rock excavation was not allowed for 24 hours after concrete had been poured on the site, and backfilling was not permitted until the concrete had achieved its required 28-day compressive strength. Field-cured cylinders were used to determine whether required 28-day compressive strengths were achieved, which, thus, allowed backfilling to be performed at an accelerated schedule. The stop log bays foundations, crest gate foundation, as well as upstream and downstream training walls/bridge abutments were all poured throughout the winter in this manner with great success. Side seals and heating elements for the hydraulic crest gate were

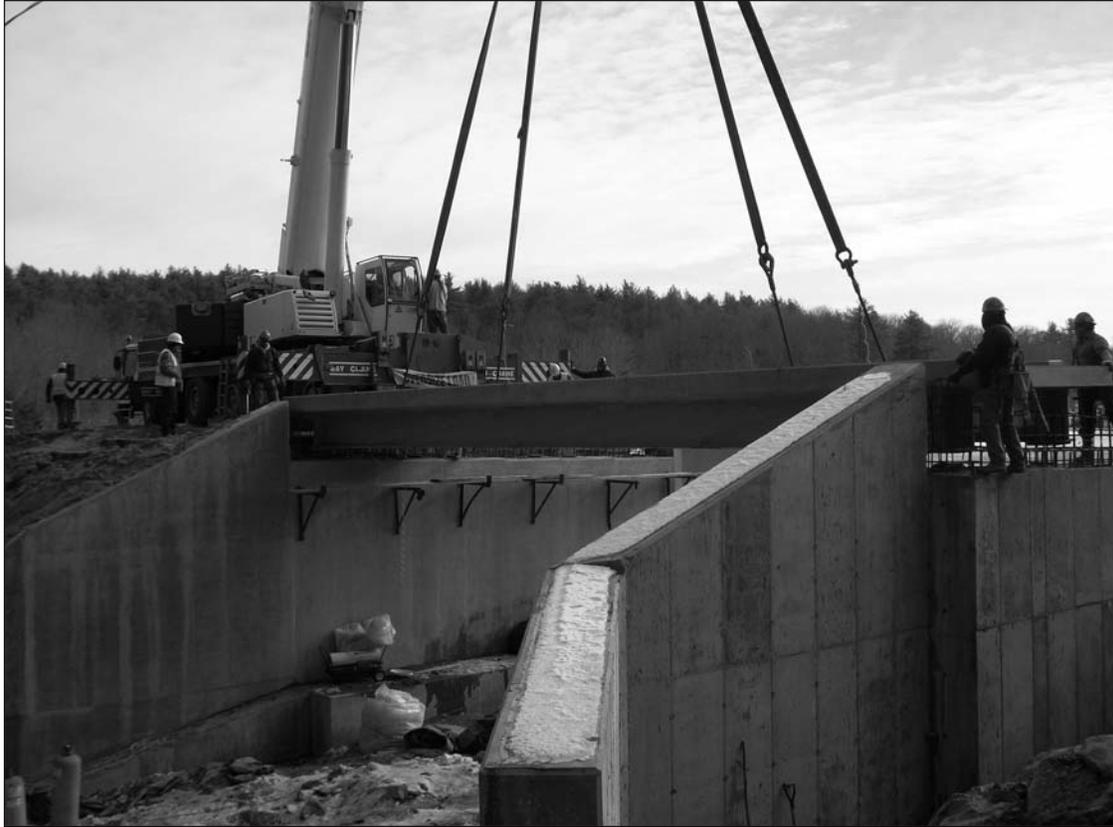
**FIGURE 8. New spillway bridge installation.**

The bridge installation was performed using a 60-ton crane set up at the east (right) abutment of the spillway (see Figure 8 on page XX). Completing the spillway backfilling operation was critical since it needed to be completed ahead of the bridge installation in order for the bridge and Tolland Road to be reopened to the public by March 2011. The bridge was fabricated in the three sections, which were trailered individually to the dam and staged on the dam crest. The crane was able to set each bridge section into place in one day. The grouting of the bridge sections and the installation of the bridge railings were completed over a two-week period and the bridge was opened on schedule on March 18, 2011.

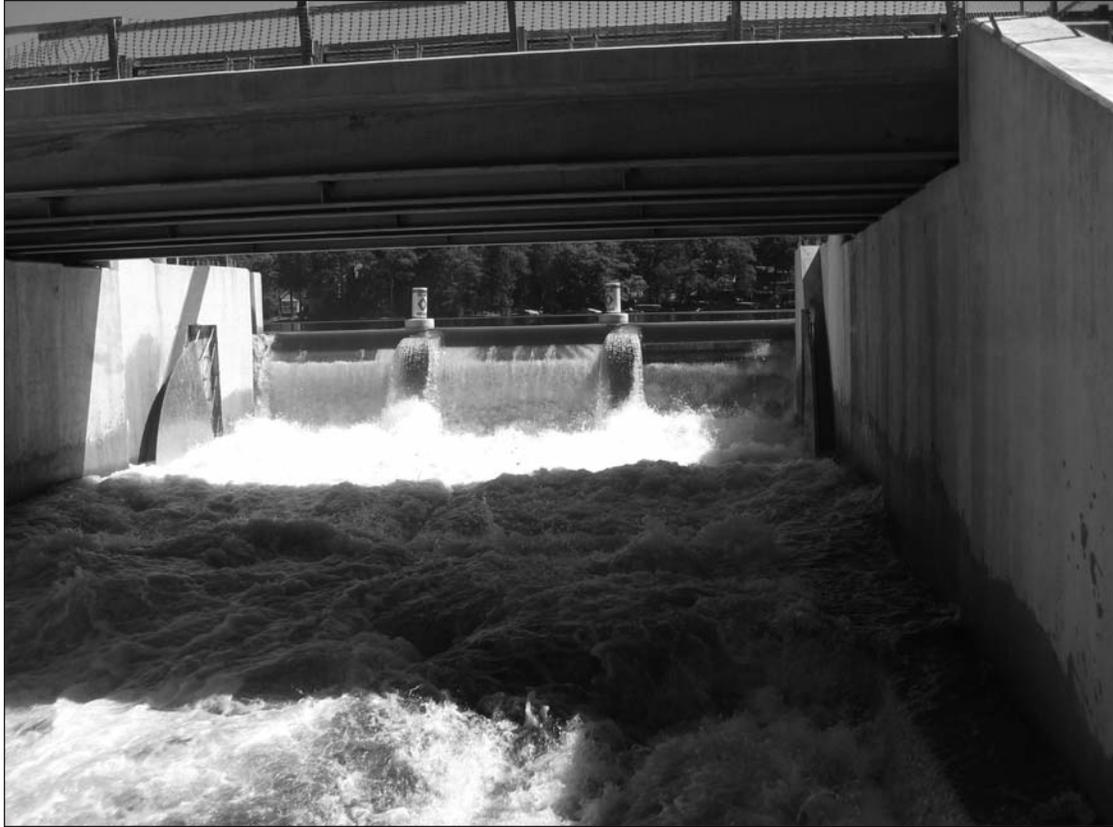
**FIGURE 9. Spillway flow due to Tropical Storm Irene.**

Between the first and second construction seasons, on August 27-28, 2011, Otis Reservoir received between about 7 and 10 inches of rain from Tropical Storm Irene. In anticipation of the storm, the DCR began to lower the reservoir level with the outlet gate two days prior to the storm’s arrival in the area. The outlet tower slide gate was kept open during and after the storm to help control the reservoir level. By the time the storm hit, the DCR had removed up to three rows of stop logs (1.5 feet). The reservoir level eventually rose to about 12 inches over normal pool (as seen in Figure 9) on August 29, 2011, which is about 6 inches above the maximum reservoir level used to design the stop logs. On September 1, 2011, the DCR reported that the three rows of stop logs had been replaced and gate in the outlet tower was closed. The DCR inspected

the spillway and did not observe any noticeable damage.

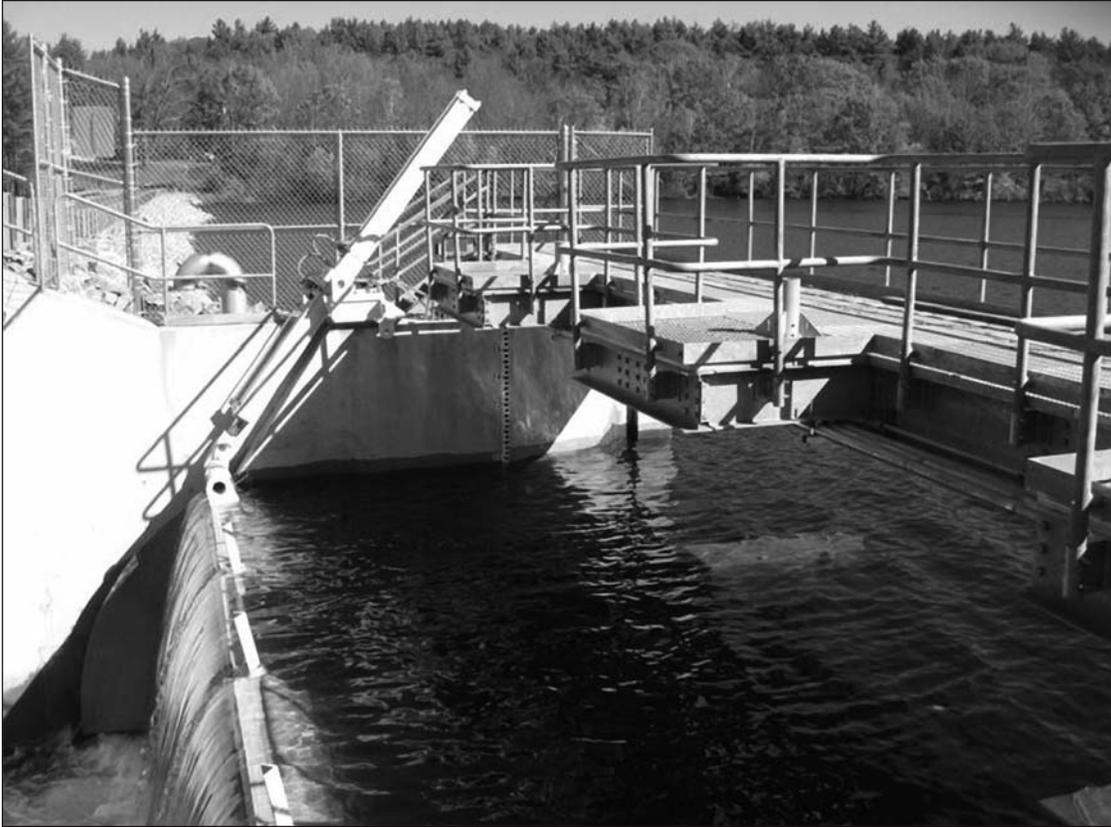
**FIGURE 10.** Water flowing over the completed crest gate.

The crest gate (shown in Figures 10 & 11) was installed by the end of December 2011. The hydraulic system was installed and tested as part of the “dry test” in January 2012. A “wet test” of the crest gate system was also performed shortly thereafter. Although the reservoir was at the winter pool elevation, water could be pumped from the reservoir into the area between the stop logs and crest gate. So, once again, the inclusion of the stop logs provided a benefit to the project that went beyond their primary objective.

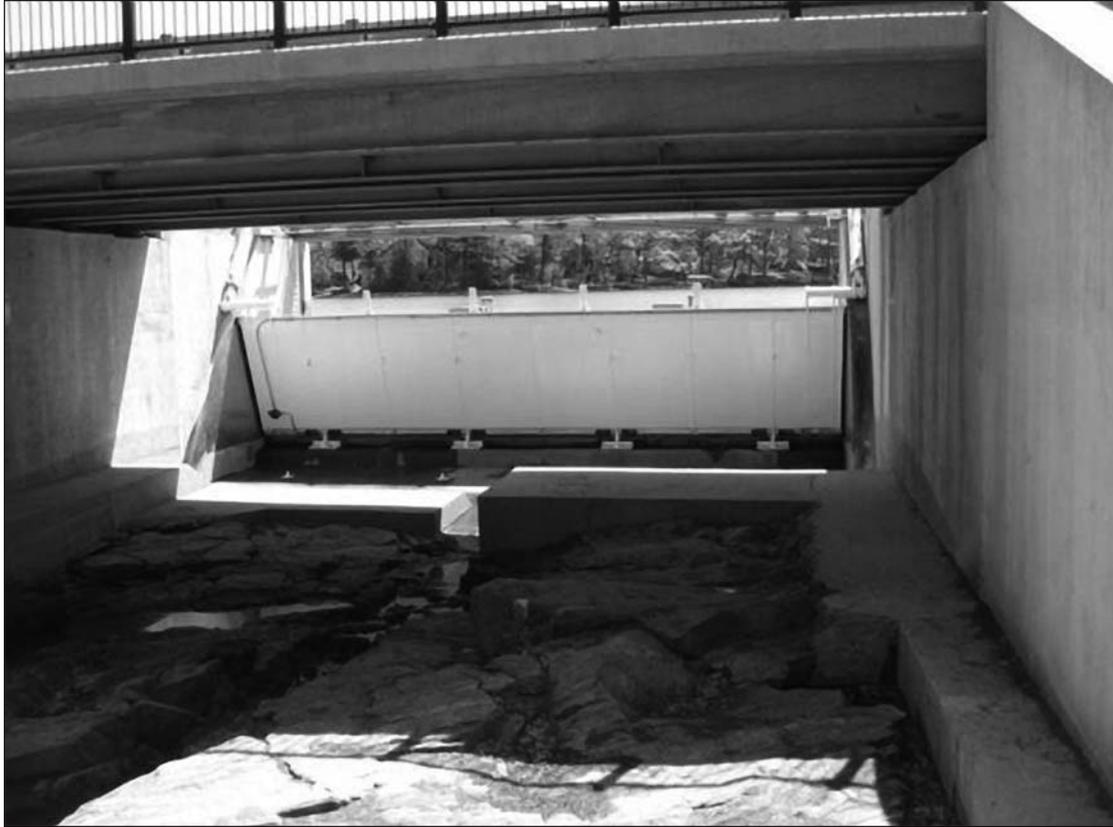
**FIGURE 11. Complete crest gate in in the spillway.**
