Tighe&Bond

CURED IN PLACE PIPE (CIPP) PROCESS, RISKS, & CONTROLS

Dr. Scott Smith CSP
Safety & Health Director
Tighe & Bond

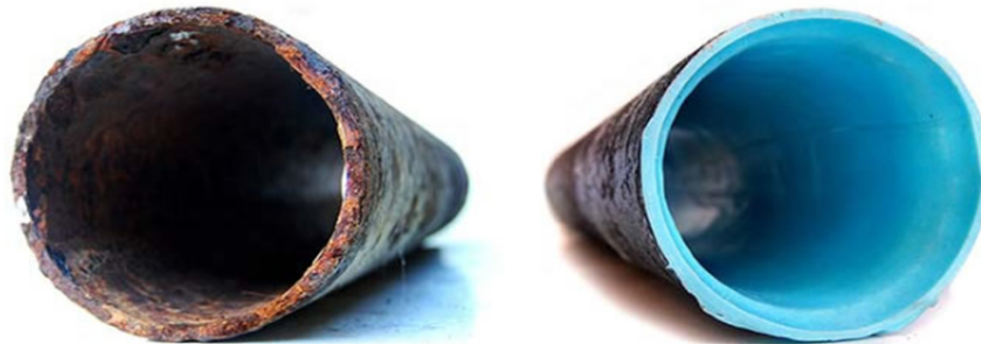
- CIPP is designed to be a trenchless system
- Invented in London England in 1971
- Implemented in Europe across the 70s
 - Eric Wood invented the CIPP process to control a leaky pipe in his garage
 - He didn't want to pull up the flooring
 - He called his product Insitu Form (form in place)
 - Applied for patent January 29, 1975
- Insituform Technologies commercialized the product
 - Brought it to the United States

- It is estimated the 50% or more of pipe repair is now done with CIPP methods
- Generally, < 60 min cure time

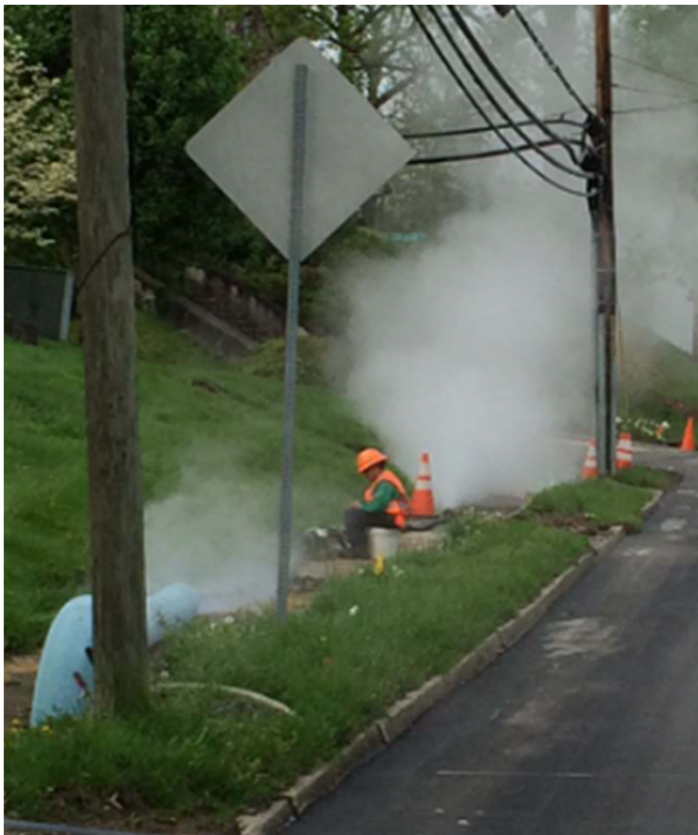
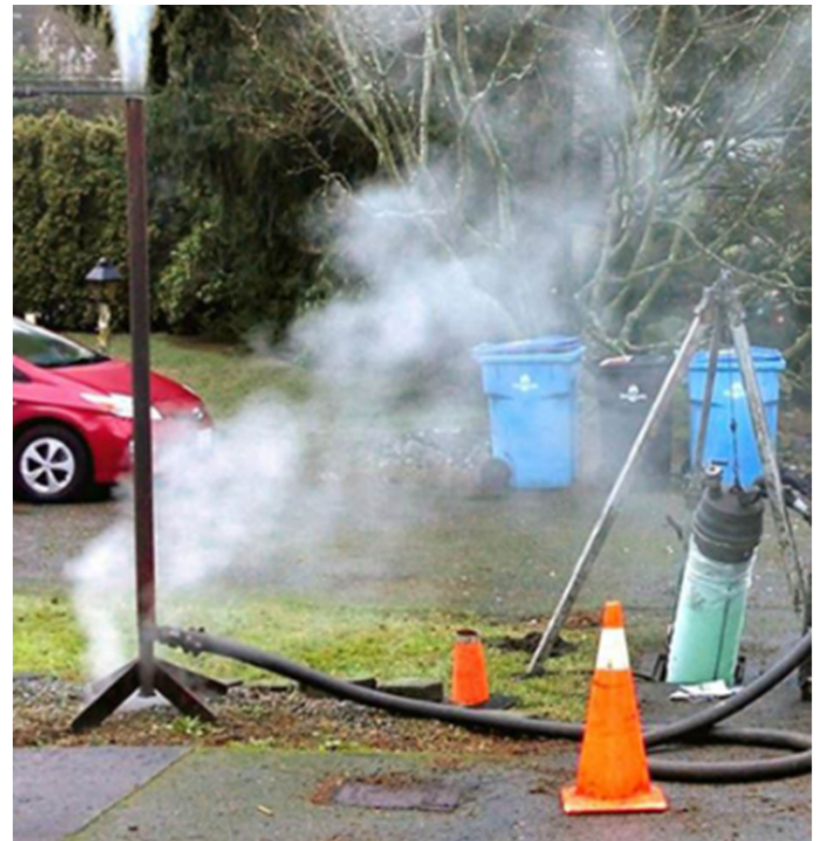
Chemicals, in varying amounts, are released into the air throughout the process.

Into the worksite, through nearby pipes, residential pumping, open windows, doors, foundation cracks. Sometimes community members are notified of work, other times not.
