Summer Street Bridge

Overview

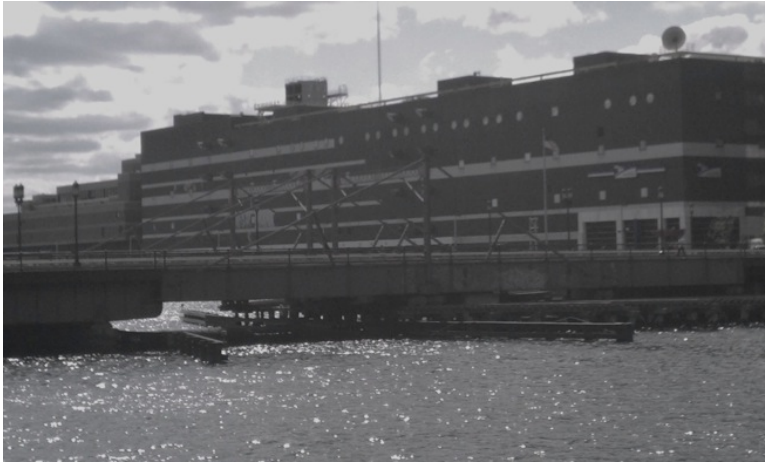
This bridge is a movable retractile bridge (a real "draw bridge") built in 1899 by the Berlin Iron Bridge Company (which can be seen in the steel over the roadway).

This type of bridge is mounted in a skewed position on trucks or carriages on one side of a body of water. To open the channel to waterway traffic, the bridge is "retracted" or withdrawn to a place out of the navigation channel by the use of cables and pulleys.

This bridge is actually two separate bridges. Each are oblique and open to traffic in that way.

The two separate spans each moved diagonally along the track to open to boat traffic. It basically rolls back using the tracks and rollers. These bridges are mirror images of each other and are each structurally separate.
